PIC32MZ EF FAMILY

PIC32MZ Embedded Connectivity with Floating Point Unit (EF) Family Silicon Errata and Data Sheet Clarification

The PIC32MZ Embedded Connectivity with Floating Point Unit (EF) family of devices that you have received conform functionally to the current Device Data Sheet (DS60001320DS80000663E), except for the anomalies described in this document.

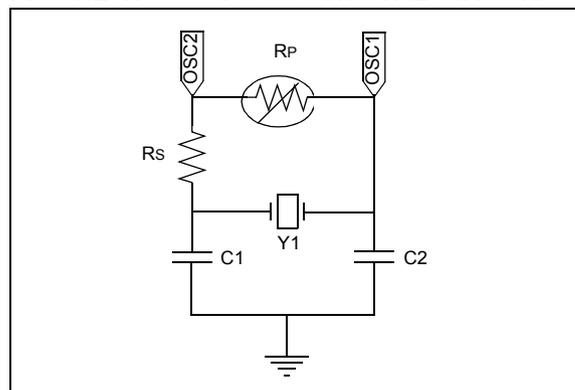
FIGURE 1: POSC CRYSTAL CIRCUIT

Revision A1 Silicon: A crystal oscillator cannot be used as an input to the Primary Oscillator (Posc) pins OSC1 and OSC2.

Revision A3 Silicon: The Posc has been tested in a normal power-up sequence and supports specific crystal operation.

The Primary Oscillator (Posc) has been characterized to operate at 8 MHz, 12 MHz, and 24 MHz when the circuit in [Figure 1](#) is implemented, and the operating conditions listed in [Table 3](#) are met.

Revision A3 Silicon Work around 1

Crystal Frequency (see Note 1)	Series Resistor (Rs)	Posc Gain Setting POSCGAIN<1:0> (DEVCFG0<20:19>)	Posc Boost Setting POSCBOOST (DEVCFG0<21>)
8 MHz	2 kΩ	'0b00 (GAIN_0)	'0b1 (ON)
12 MHz	1 kΩ	'0b00 (GAIN_0)	'0b1 (ON)
24 MHz	0 kΩ	'0b00 (GAIN_0)	'0b1 (ON)

- Note 1:** Using any other crystal frequency will require special component selection and characterization.
Note 2: A parallel resistor (Rp) should not be used to increase the gain of the POSC.
